# USING HISTORIC AERIAL PHOTOGRAPHS TO ASSESS CHANGES IN DRYLAND RIVER SYSTEMS: THE STORY OF THE PRICE RIVER IN CENTRAL UTAH

Ellie Leydsman-McGinty, Researcher III, Remote Sensing/GIS Laboratory, Utah State University, Logan, Utah

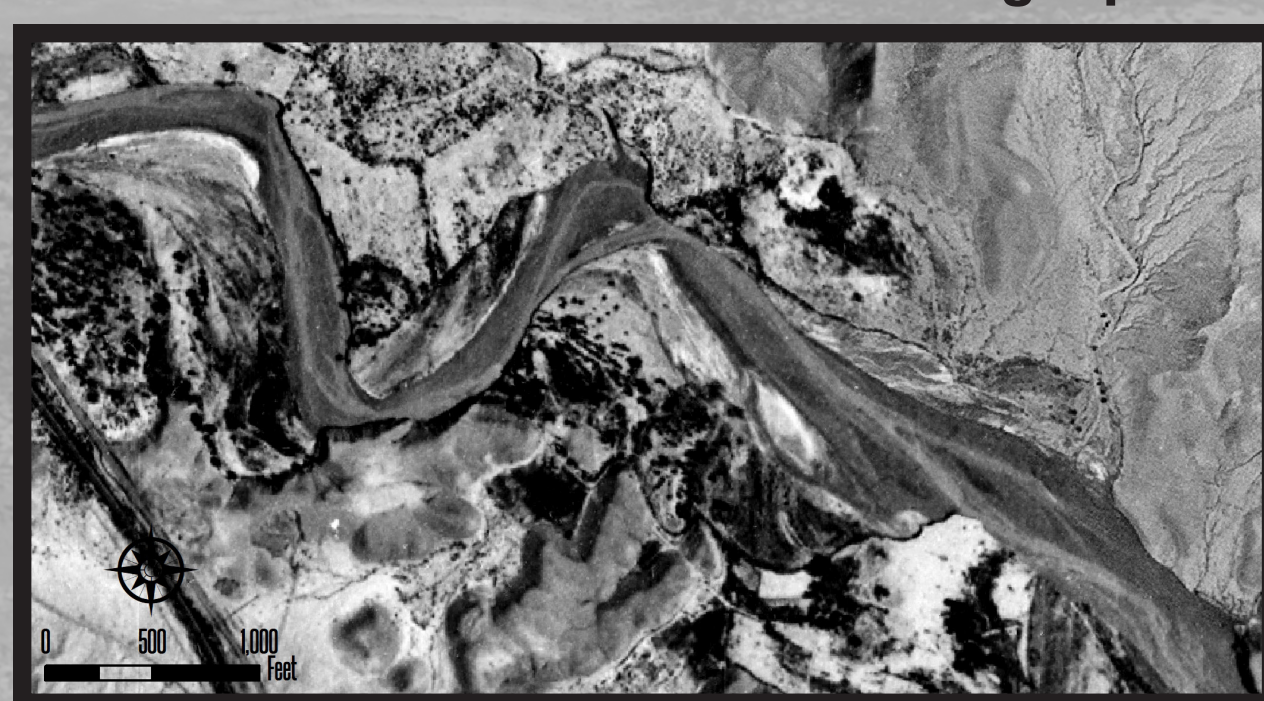
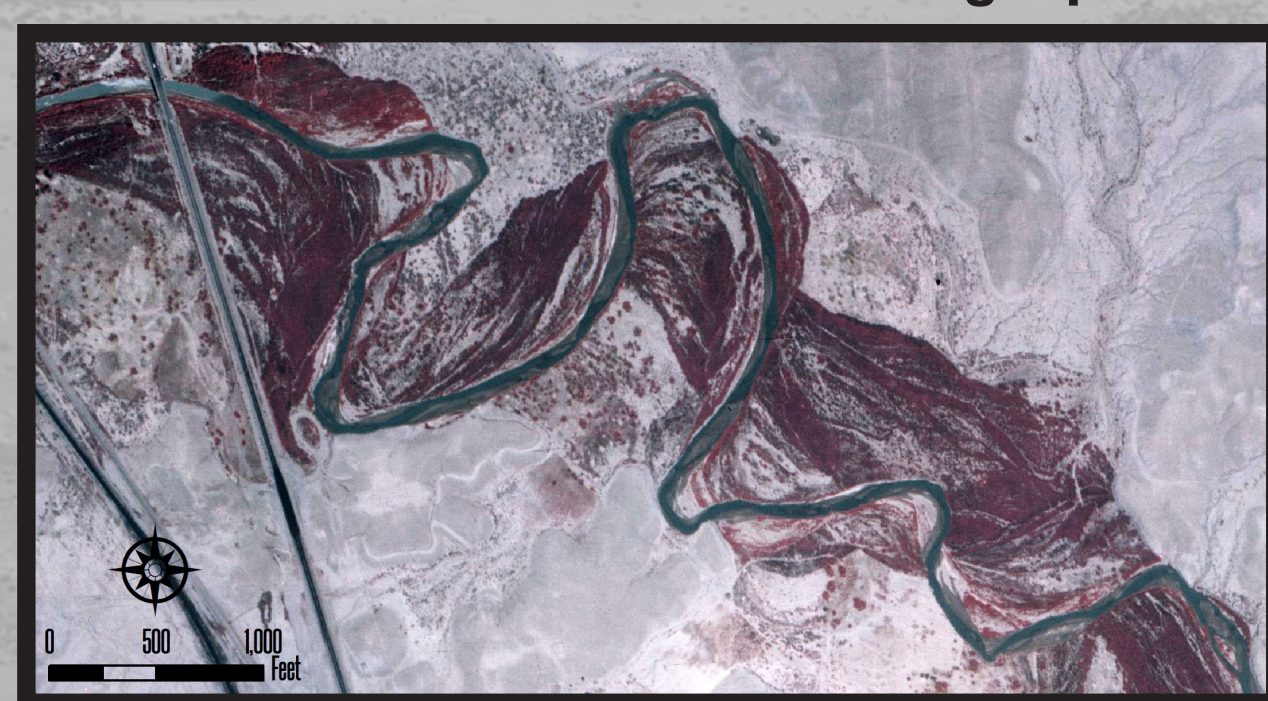
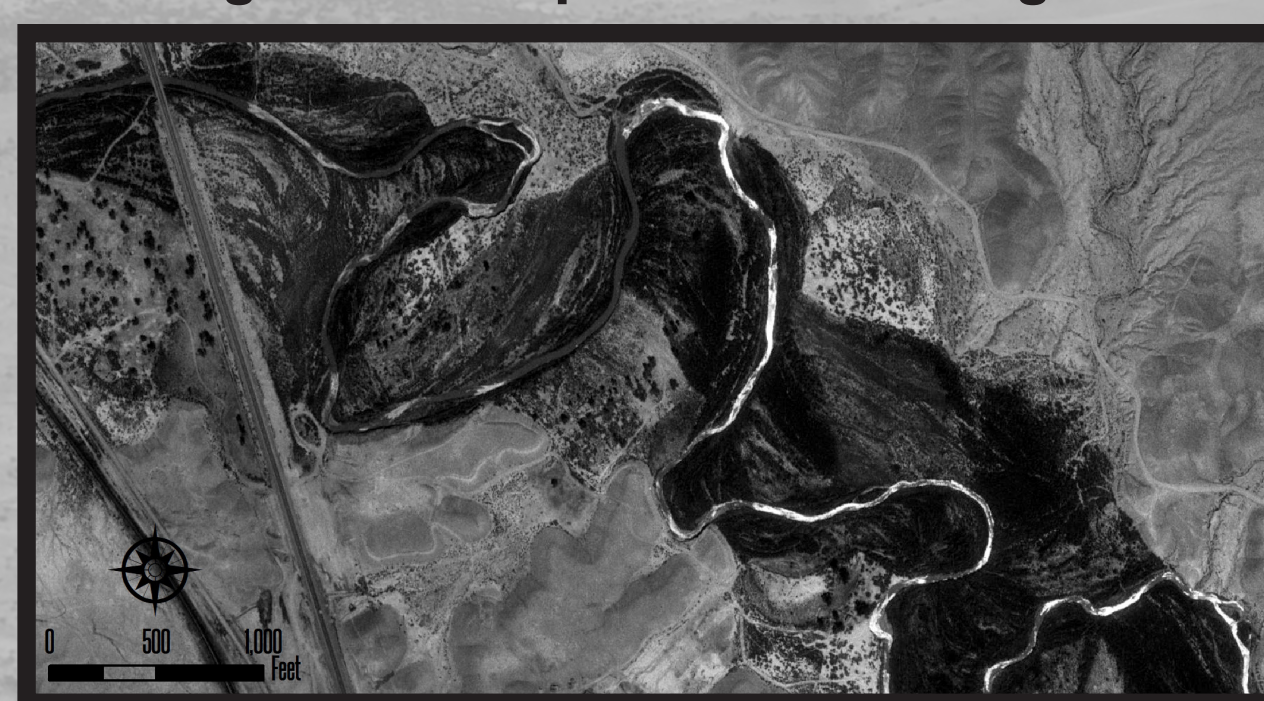
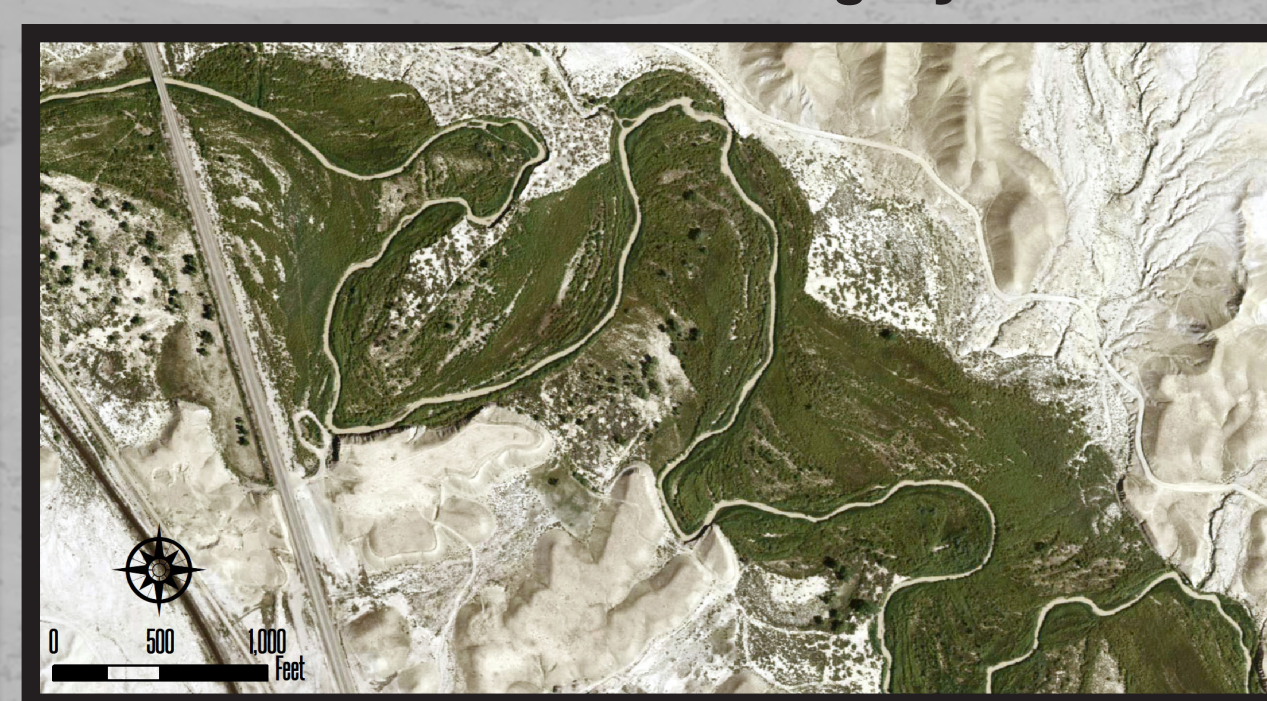
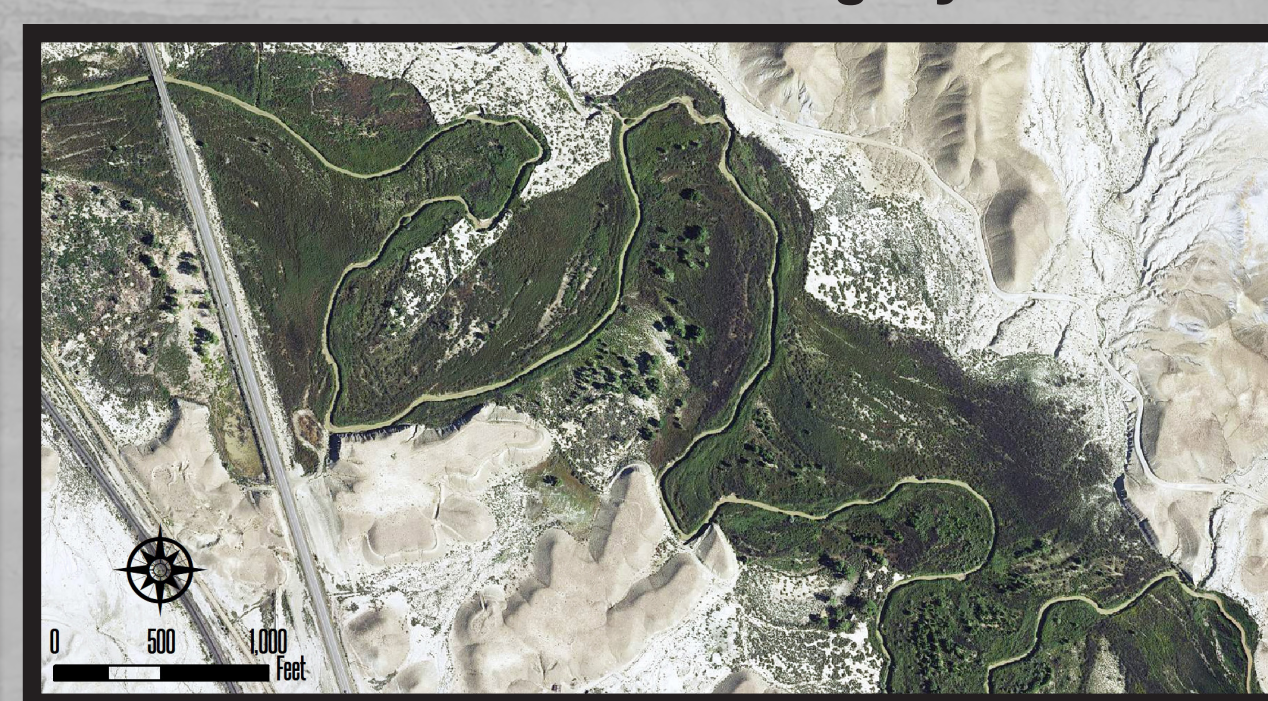
1938 Soil Conservation Service Black and White Aerial Photographs

1974 Bureau of Land Management Color Infrared Aerial Photographs

1997 U.S. Geological Survey Digital Orthophoto Quadrangles

2006 U.S. Department of Agriculture NAIP Aerial Imagery

2014 U.S. Department of Agriculture NAIP Aerial Imagery

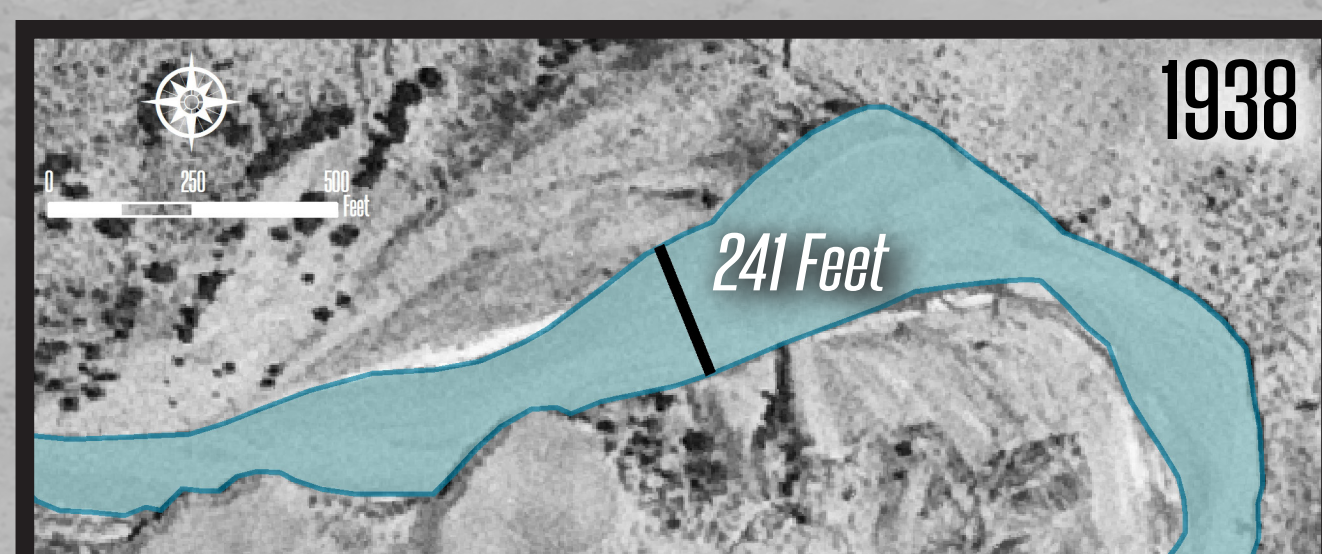
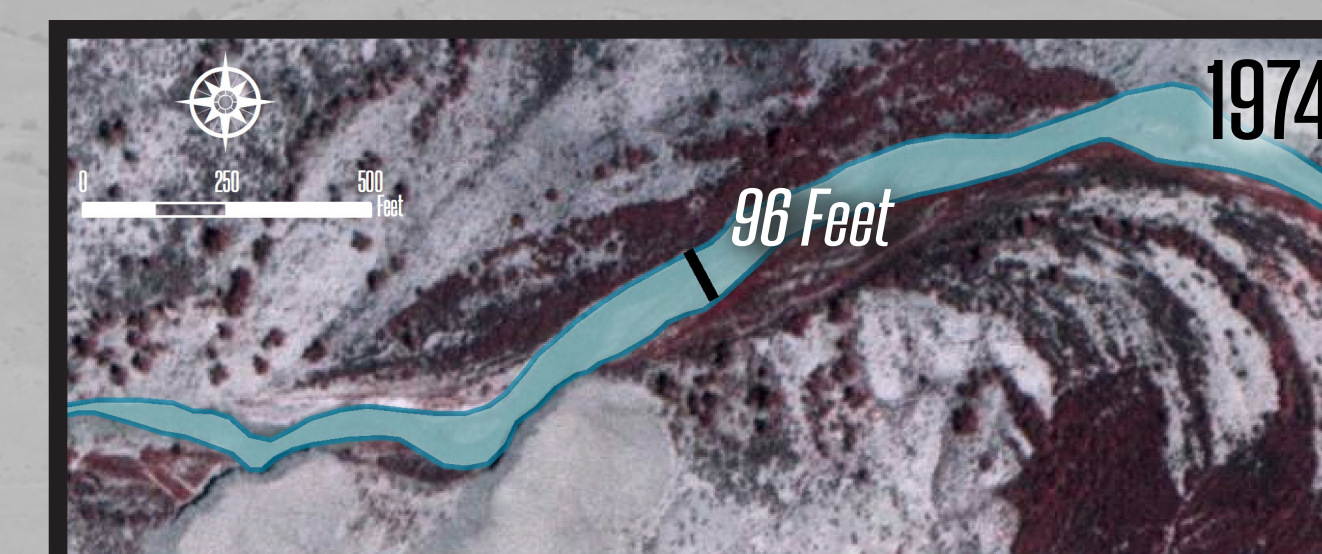
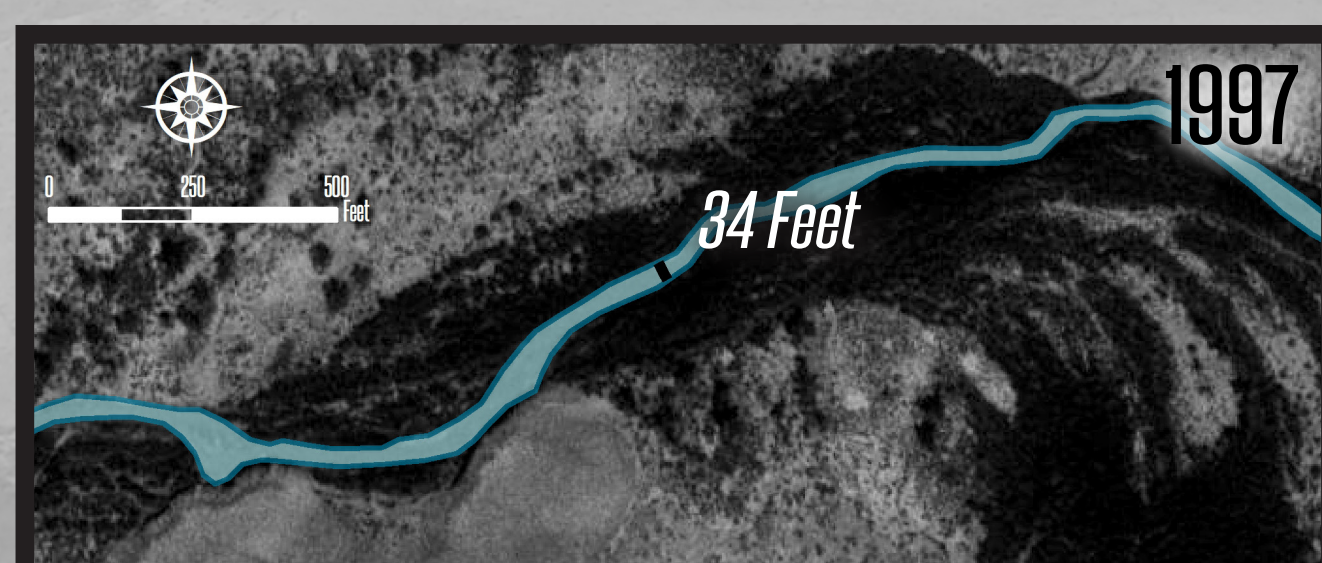
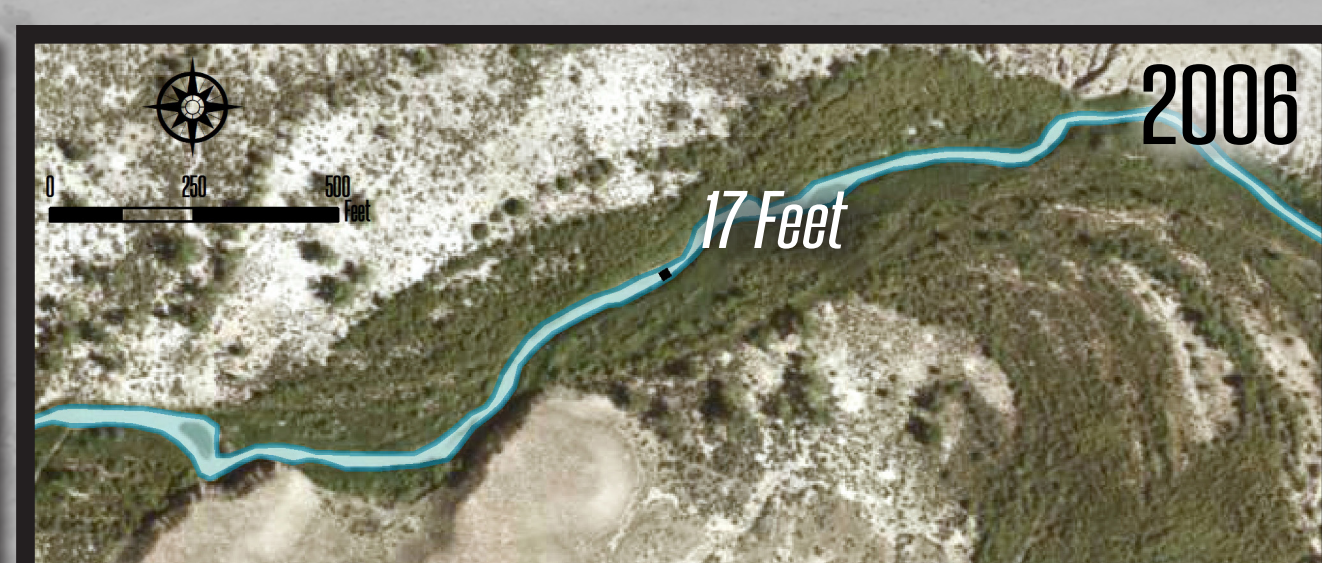
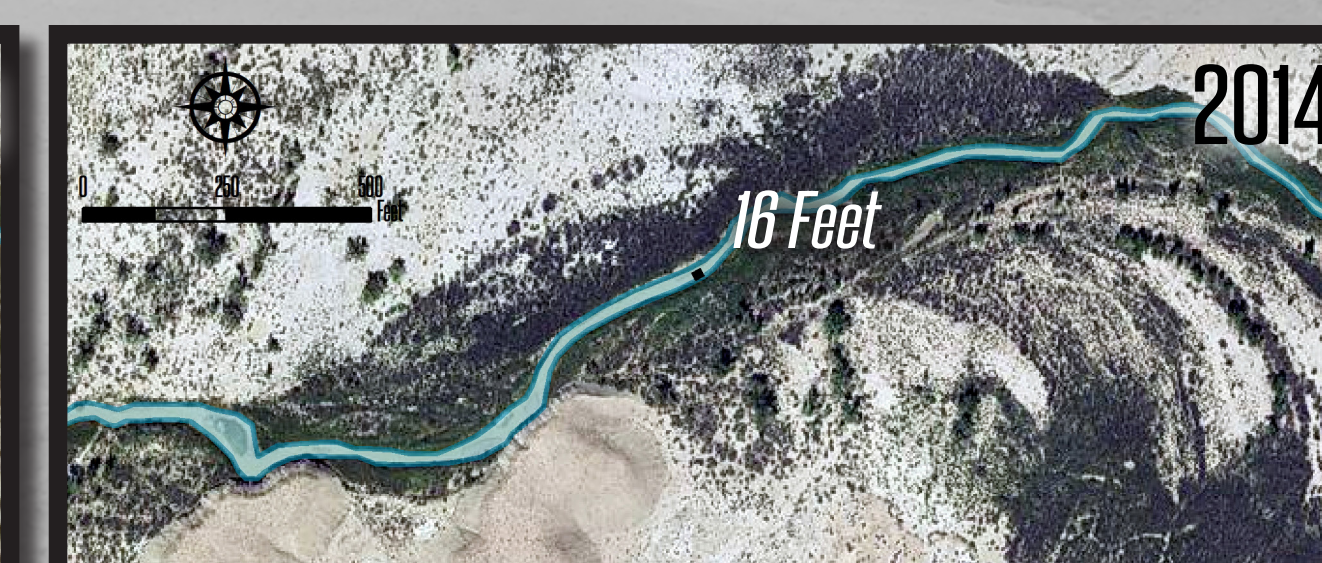
Regulated hydrologic regimes and tamarisk have transformed the channel morphology of the Price River. Multiple cross-section measurements revealed that the average channel width of the Price River has significantly decreased over the timeframe from 1938 to 2014. In 1938, the average channel width was 149 feet (45 meters) and the river was comprised of multiple threads and several point and mid-channel bars. By 1974, the average width decreased to 66 feet (20 meters), and by 1997, the average width decreased to 35 feet (11 meters). By 2014, the Price River was characterized by a narrow, confined, and incised channel with an average channel width of 26 feet (8 meters). This represents a total decrease of nearly 83 percent since 1938.

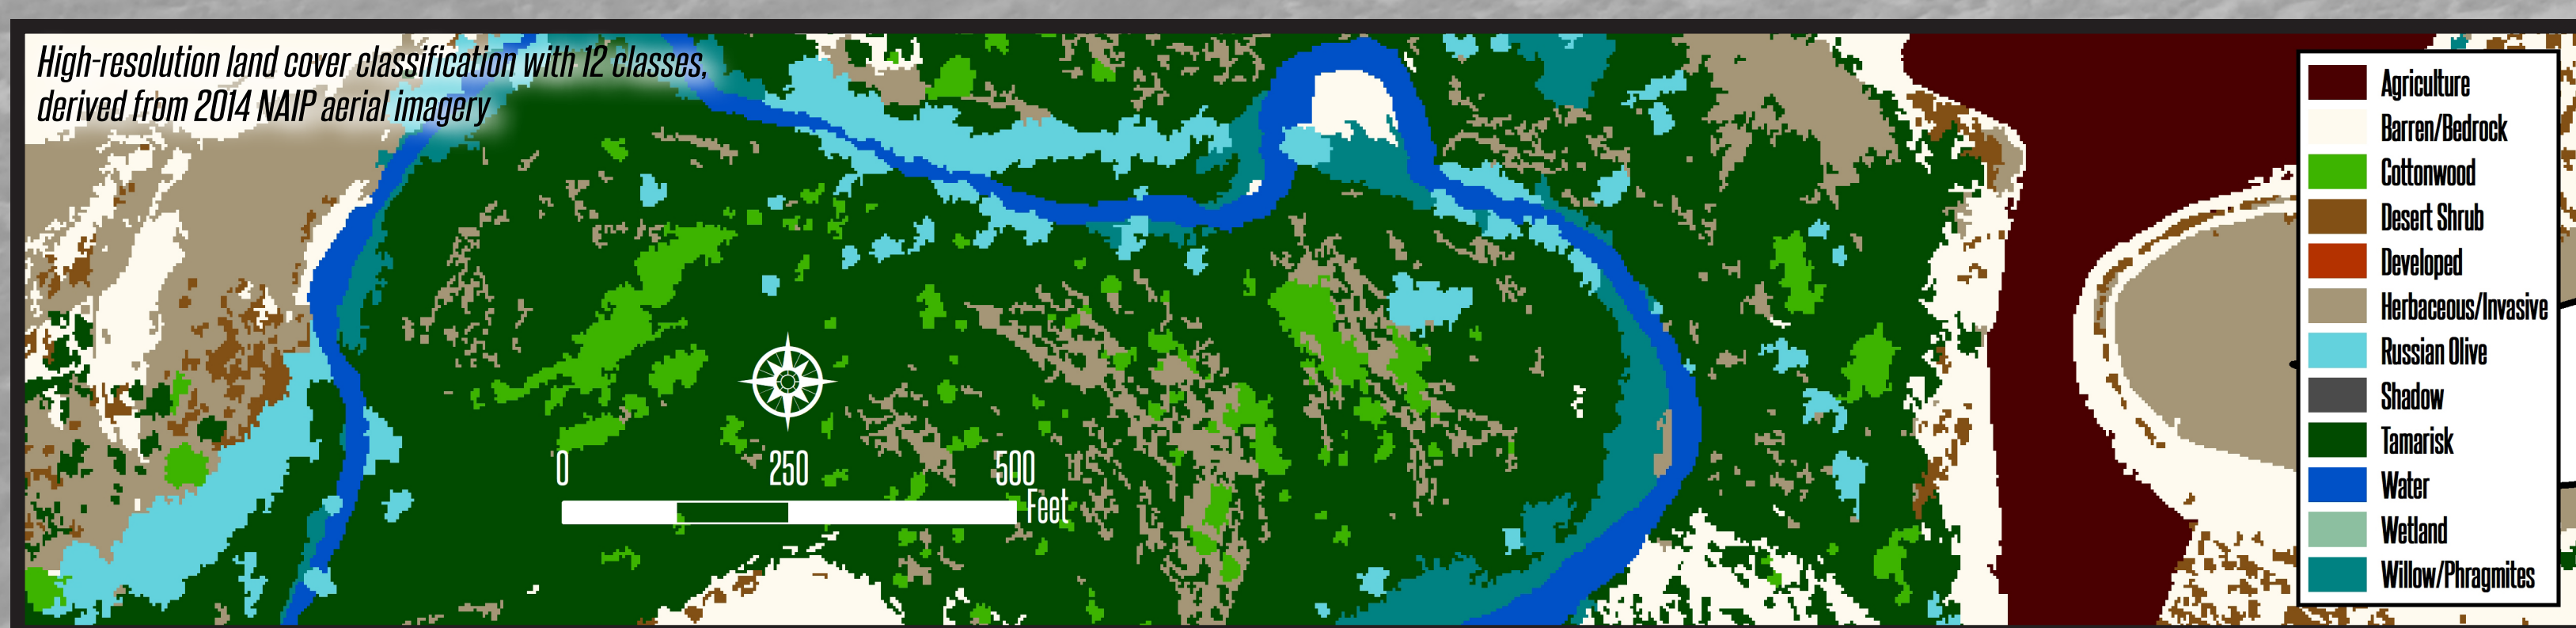
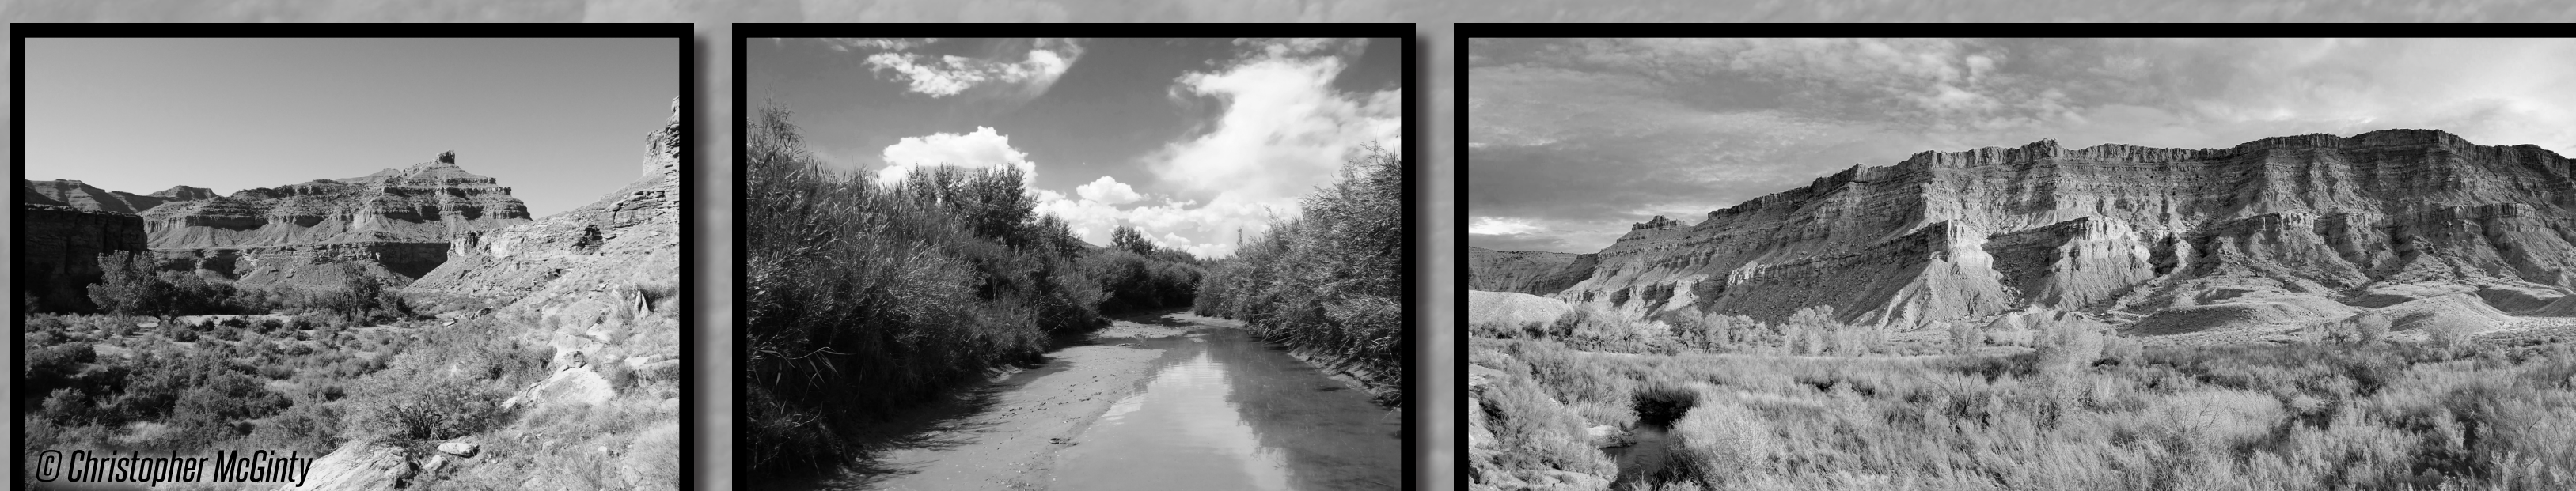
A high-resolution riparian land cover dataset was previously developed using the 2014 NAIP aerial imagery to support the design of a restoration plan for the Price River. While this dataset has been valuable in identifying the current distribution and composition of native and invasive plant species, the identification of targeted restoration sites remained unclear due to limited knowledge of historic riparian conditions. Historic aerial photographs for the Price River have enabled a more comprehensive understanding of this dryland river system. Between 1938 and 2014, there was a significant increase in total riparian land cover. In 1938, the riparian vegetation was patchy and dispersed and characterized by cottonwood gallery forests and willow stands. In 2014, the riparian vegetation blanketed the riparian corridor and largely consisted of dense monocultures of tamarisk.
